CAUSE NO. D150358C

**PLAINTIFFS' ORIGINAL PETITION**

Helen Chandler Residence  
San Angelo, Texas  
Haag File: 0614000099-249/601

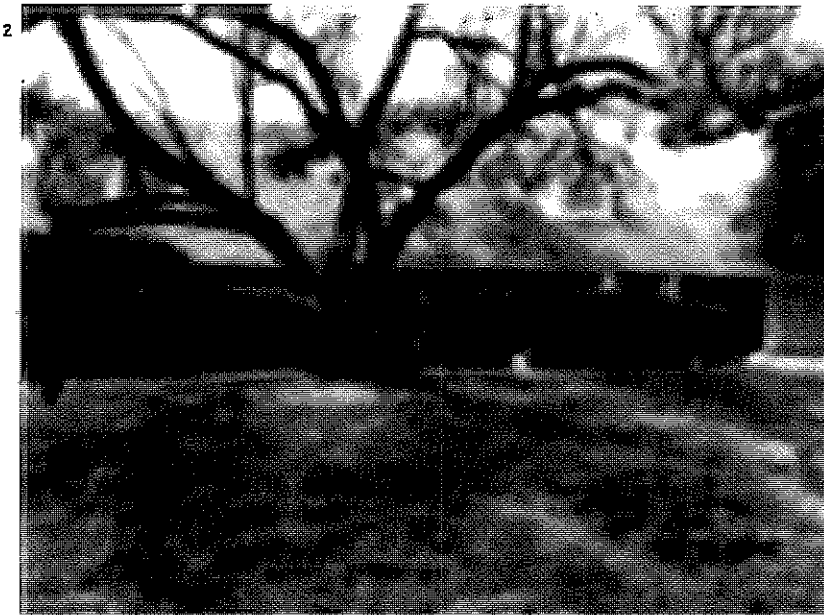
Front - North Elevation

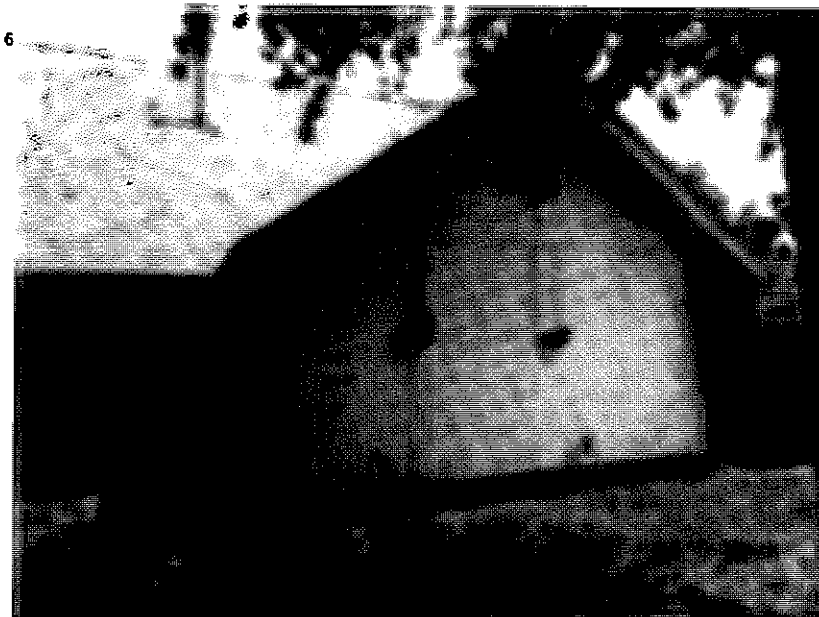
Rear - South Elevation

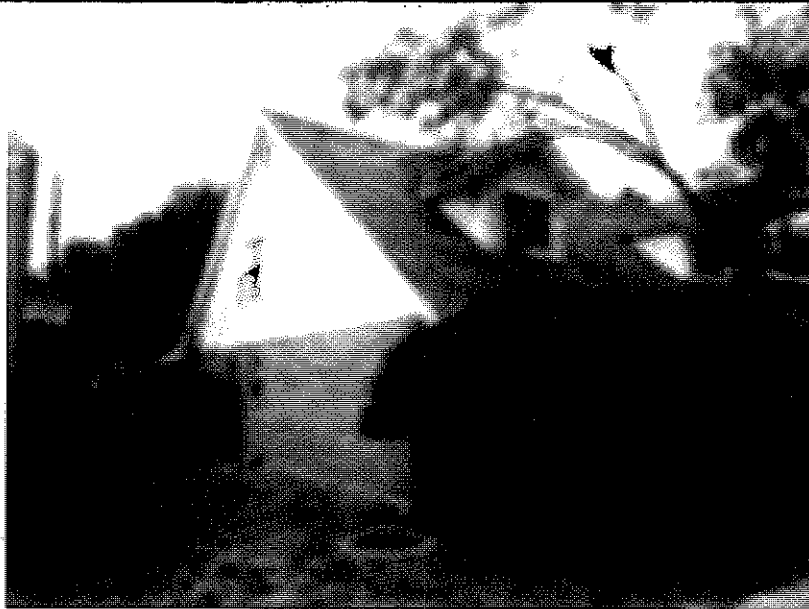
7

Left - East Elevation

East: No storm related damages were observed.

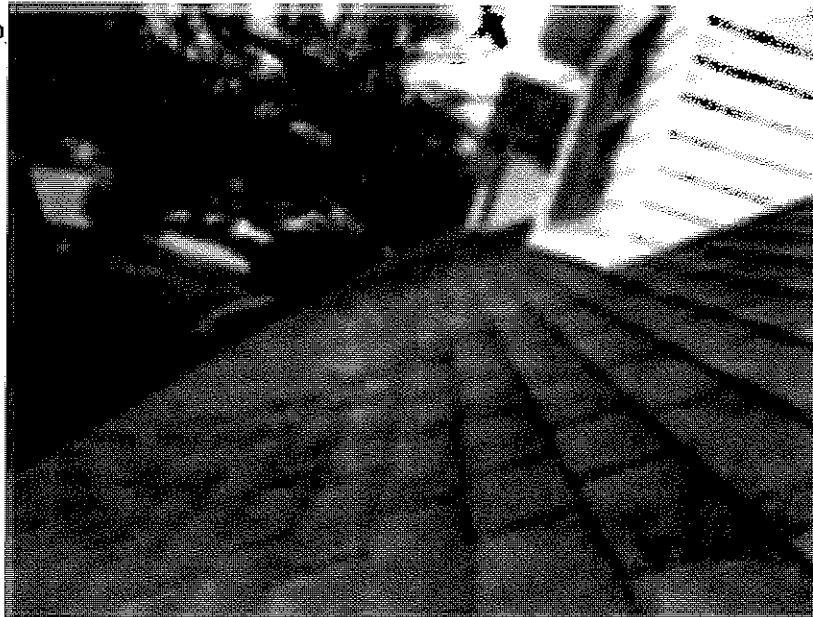
10

Roof Overview - Main Roof - North slope

North Slope: No storm related damages were observed.

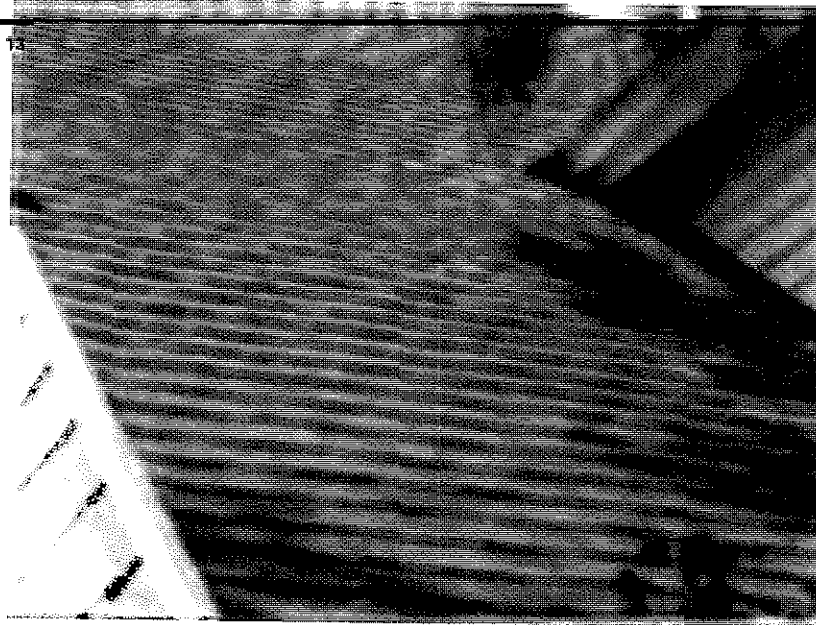
Roof Overview - Main Roof - North slope

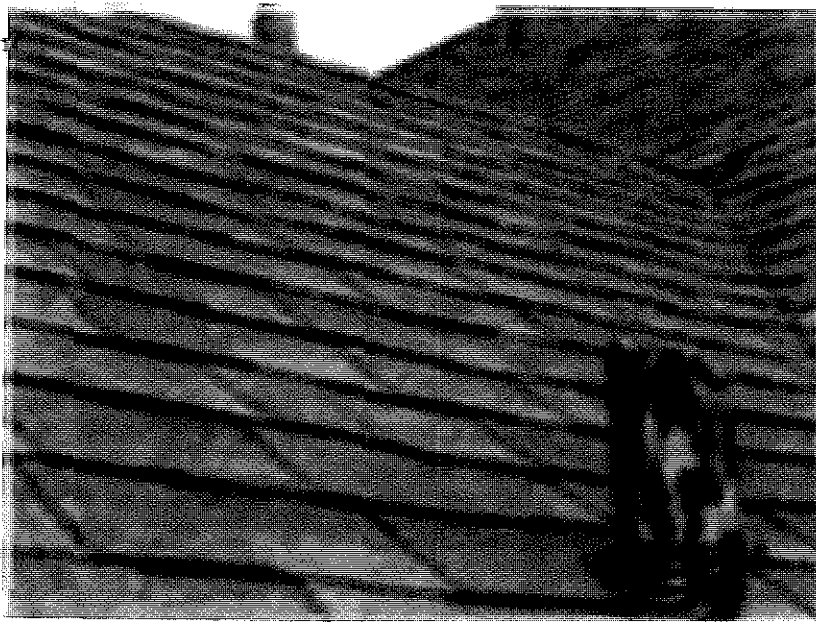
Roof Overview - Main Roof - South slope

South Slope: We observed scattered hail damage to this slope.

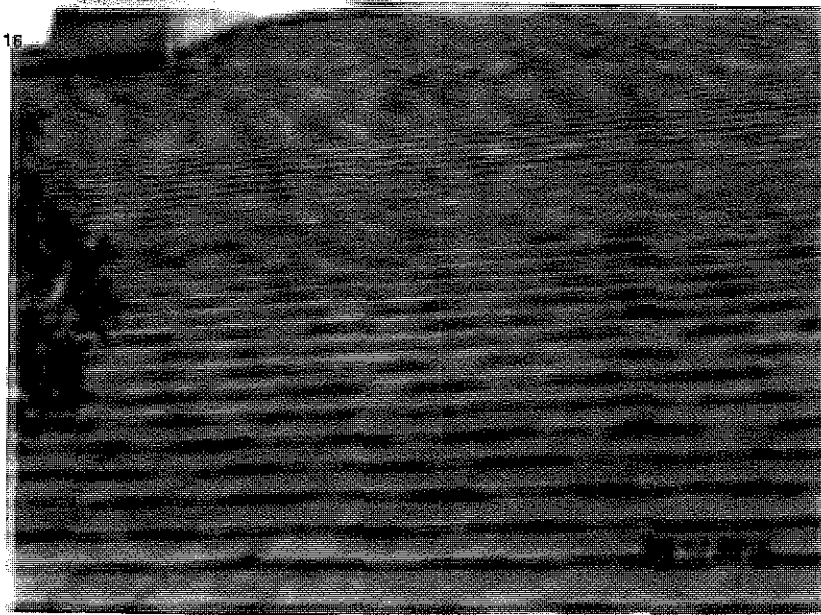
Roof Overview - Main Roof - South slope

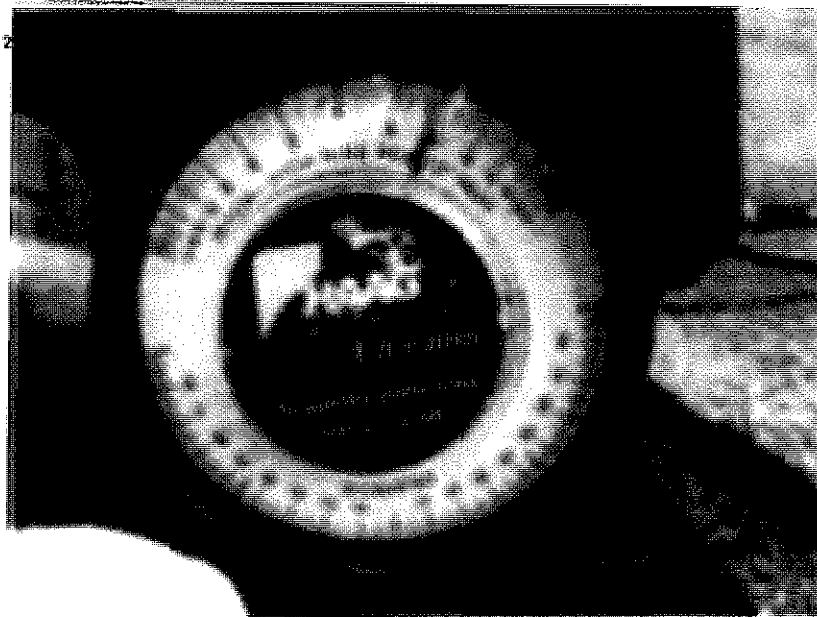
Roof Pitch - Garage Roof - 5/12 pitch

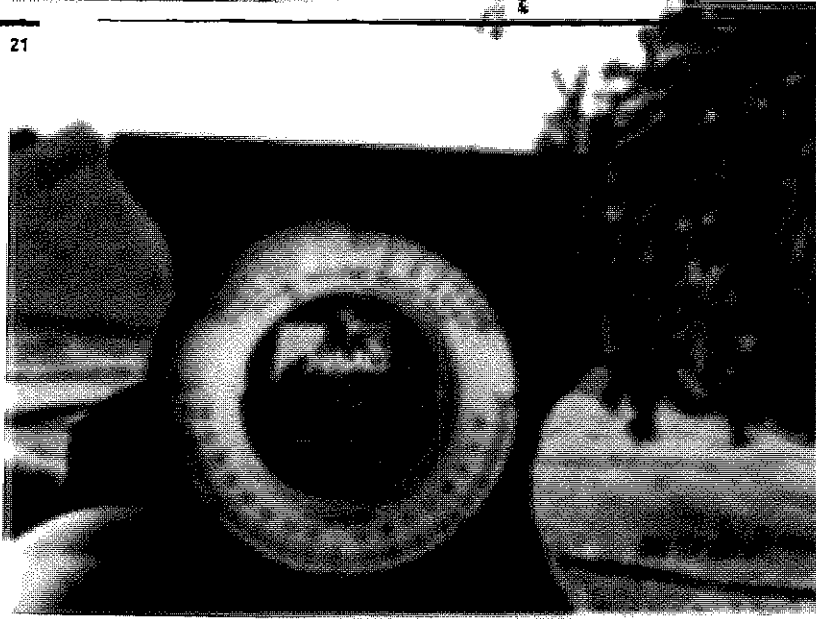
21

Roof Pitch - Main Roof - 8/12 pitch

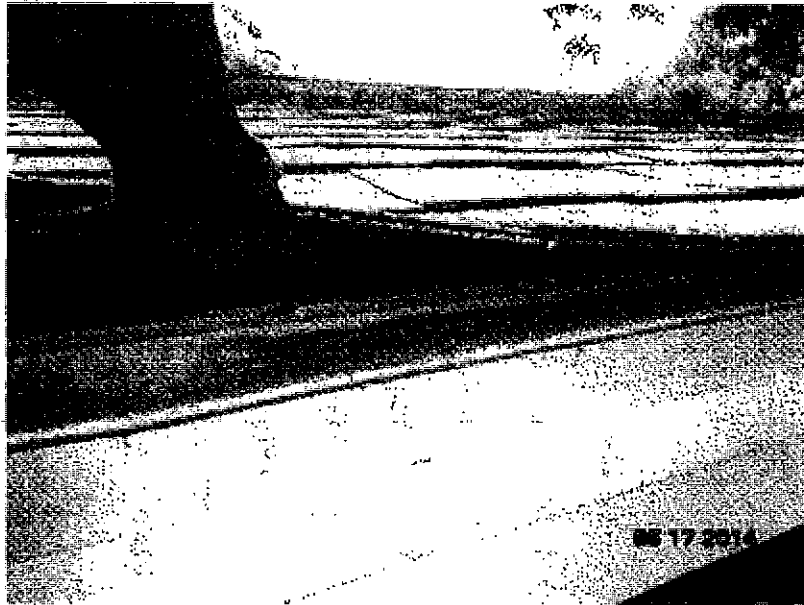
22

Roof Edge - 1 layer of shingles with drip edge

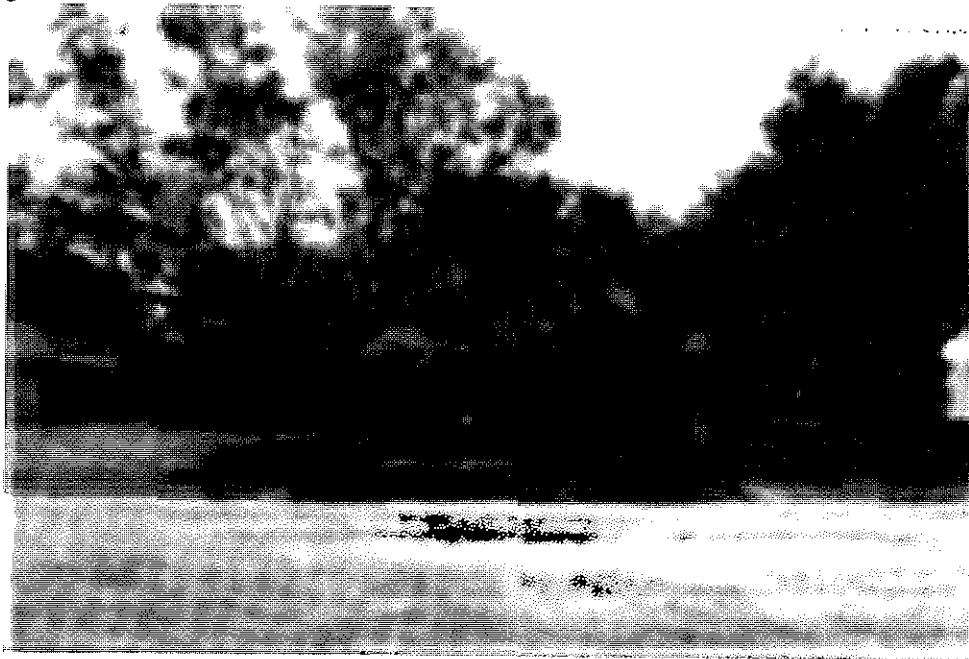
1. Property front (north) elevation.

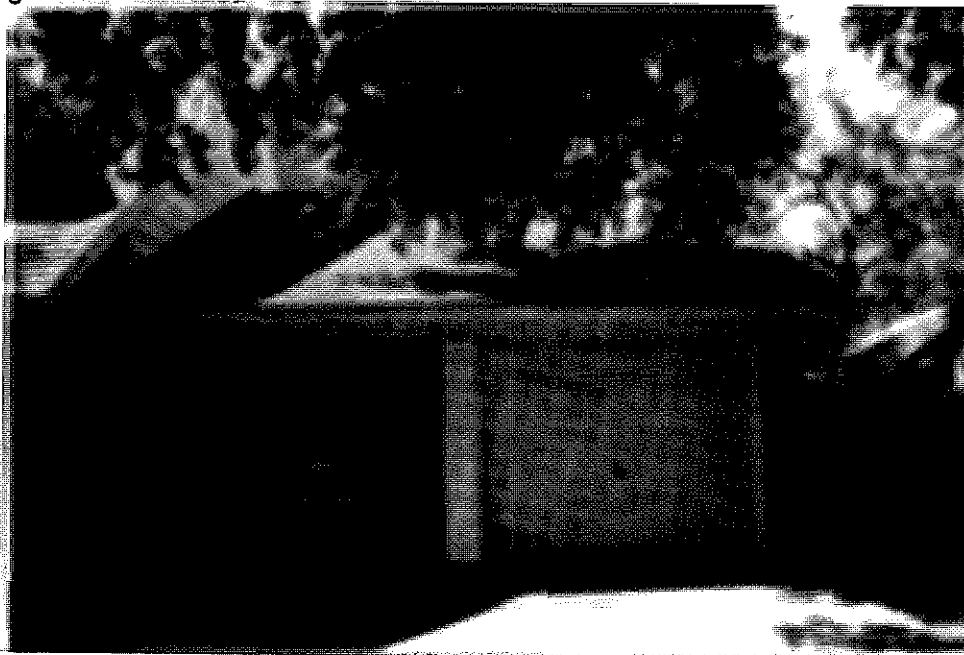
7. Garage at the building west end.

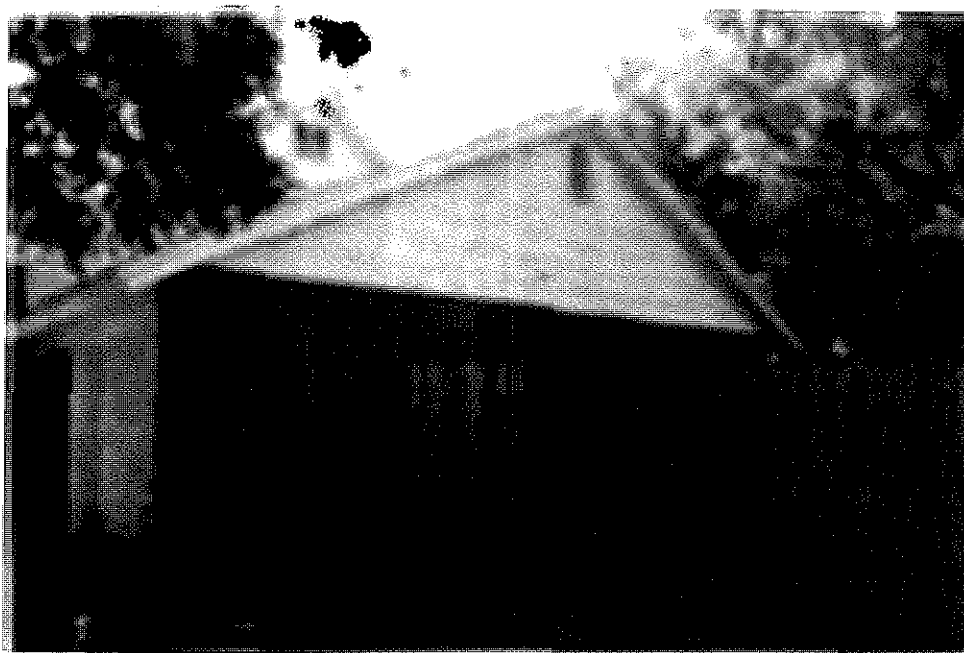
8. Building west elevation.

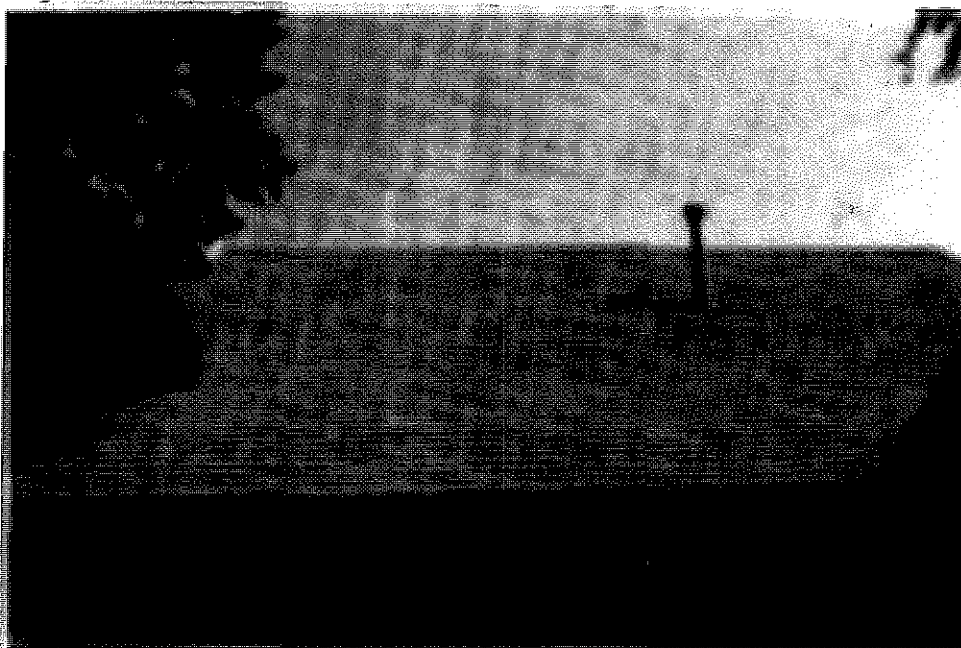
12. Roof main rear slope.

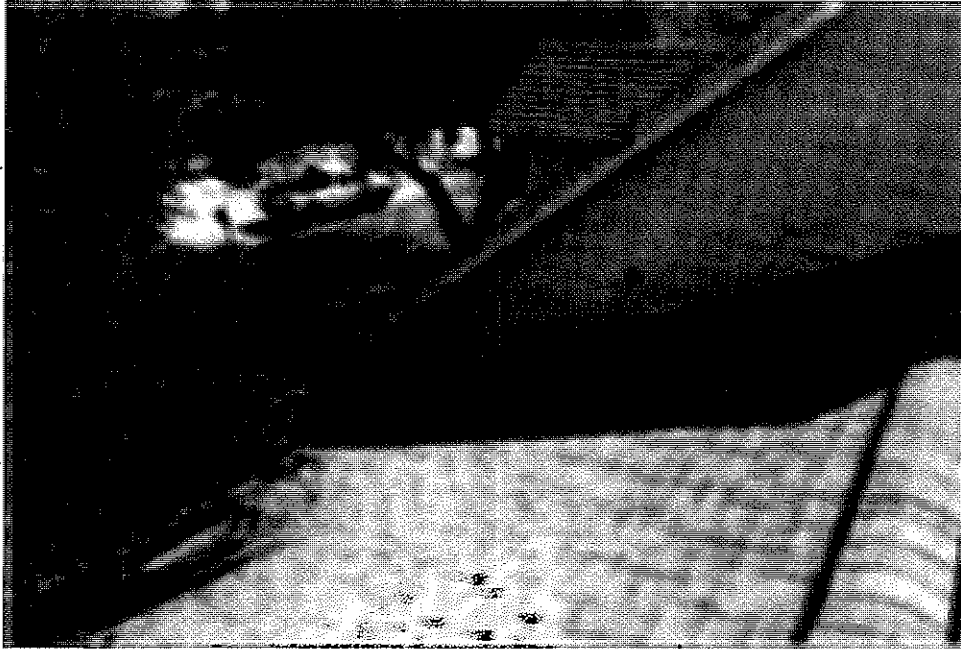
17. Panoramic view (1 of 2) of the garage roof, photographer facing east.

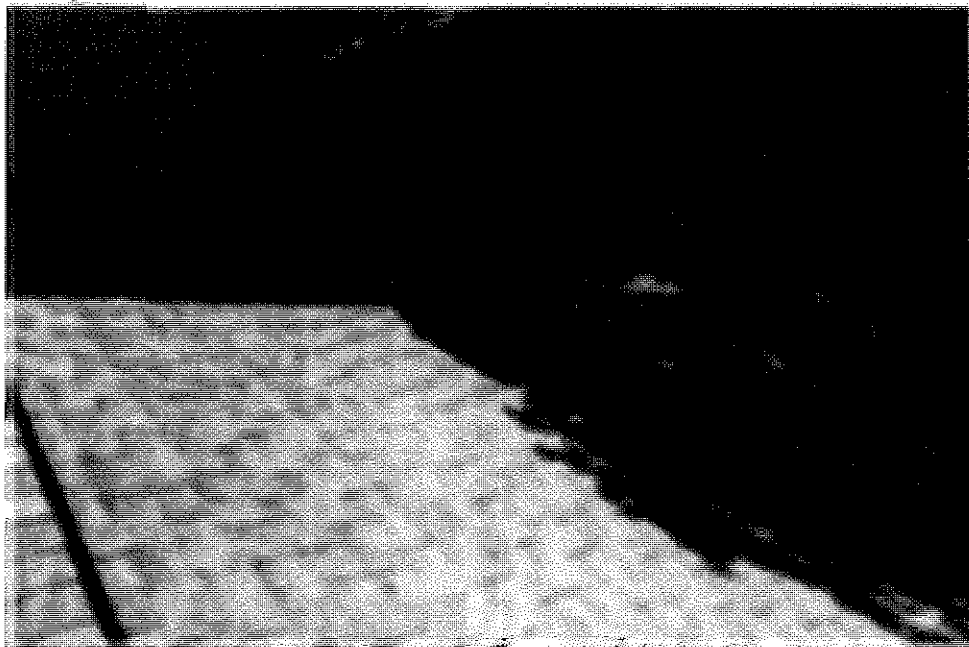
18. Panoramic view (2 of 2) of the garage roof, photographer facing east.

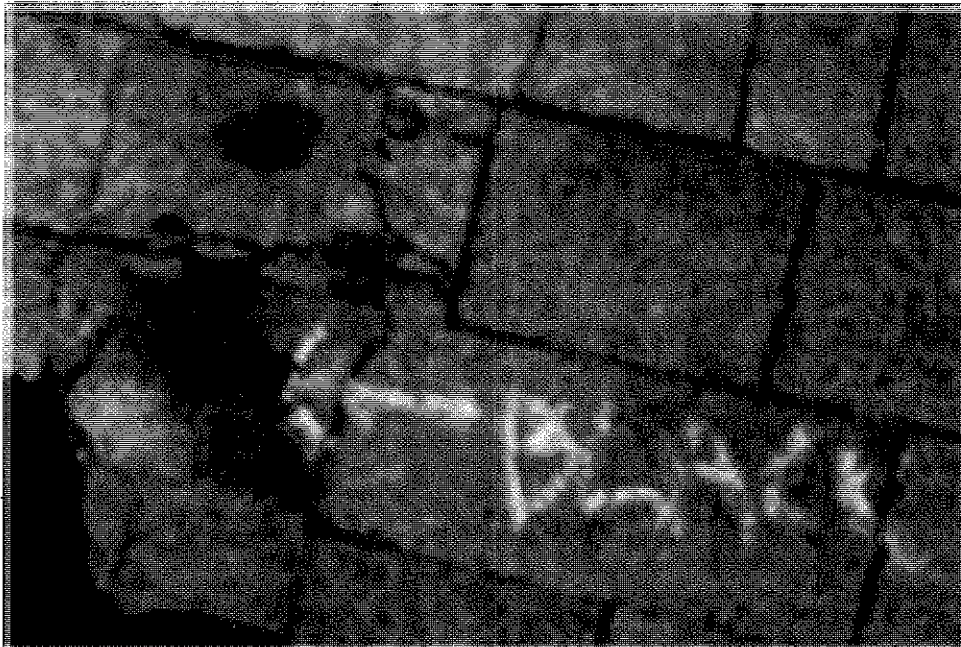
21. Close up view of the steel reinforcing matting at the south edge. Note the black reinforcing mat.

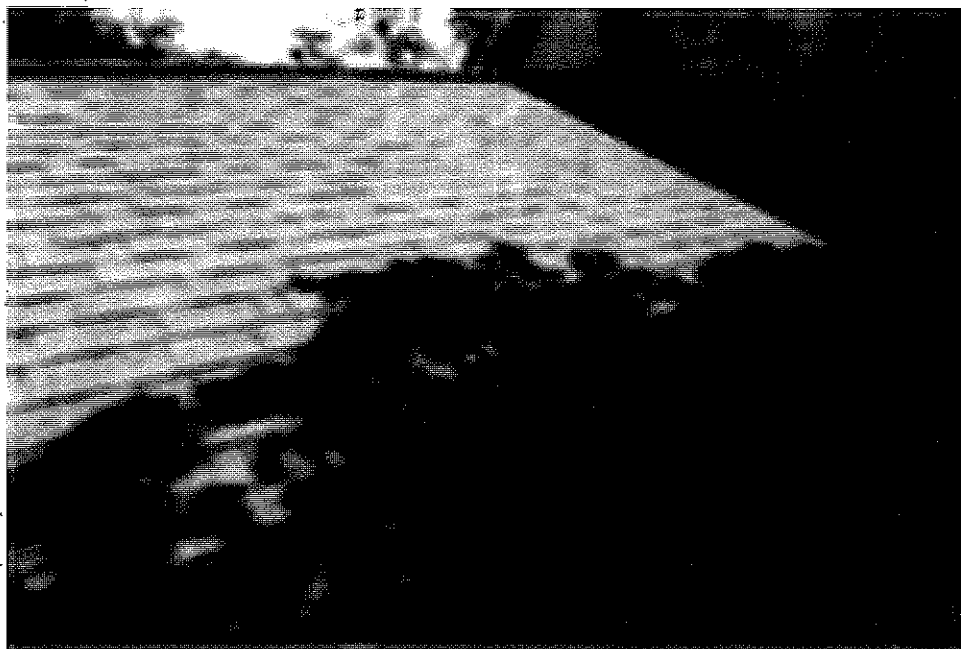
22. Garage south test area.

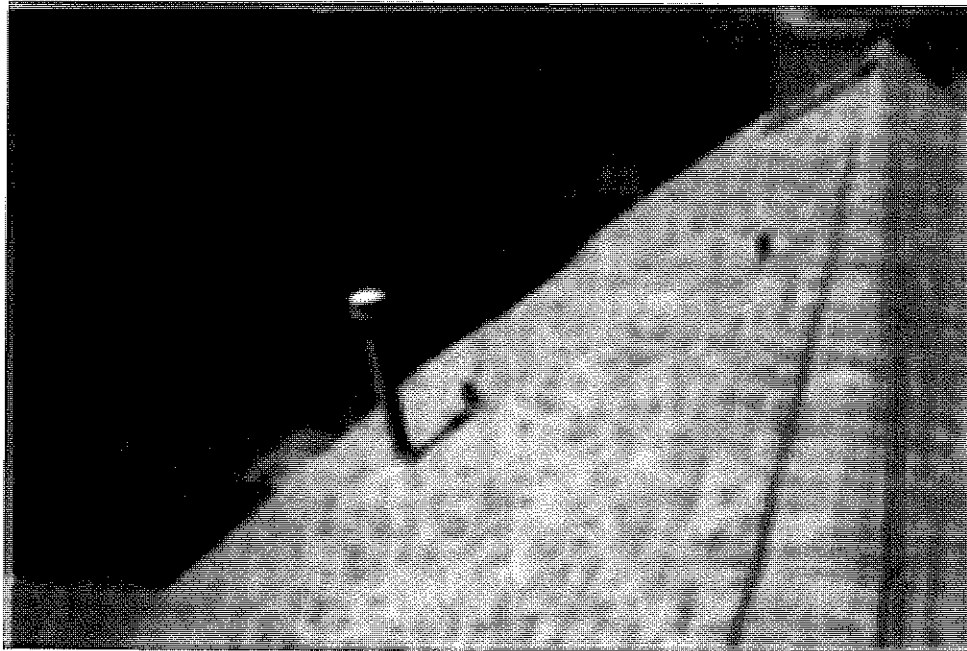
33. Panoramic view (2 of 4) of the main roof slopes, photographer facing west.

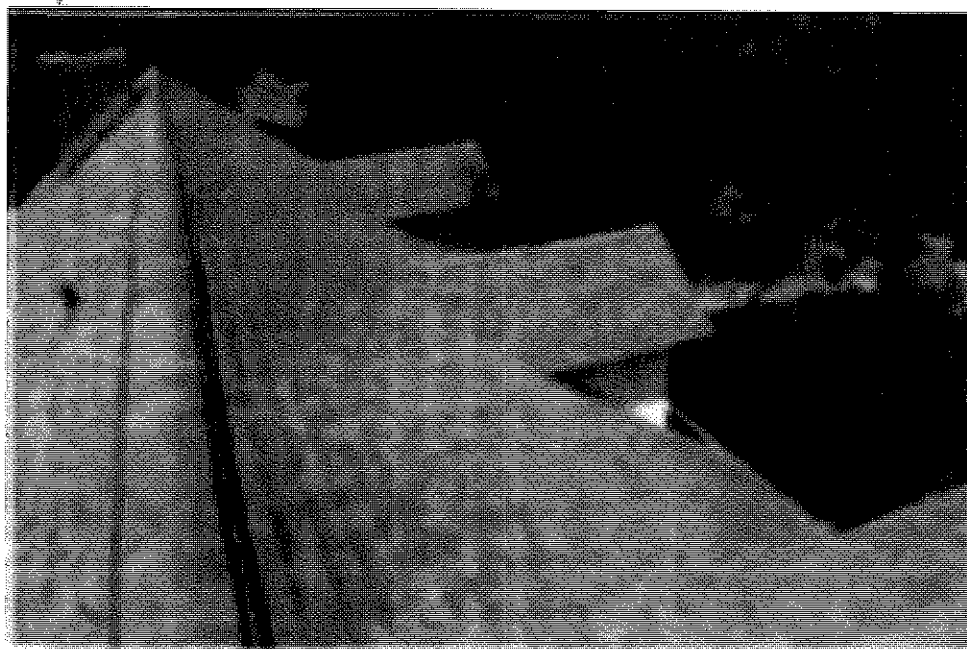
34. Panoramic view (3 of 4) of the main roof slopes, photographer facing west.

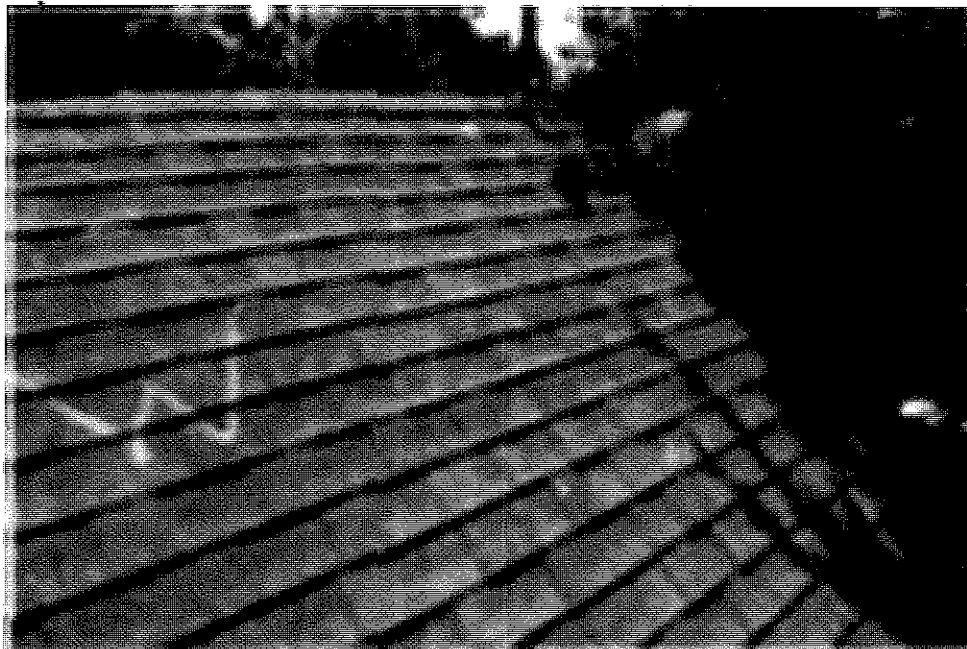
37. Panoramic view (2 of 2) of the west test area.

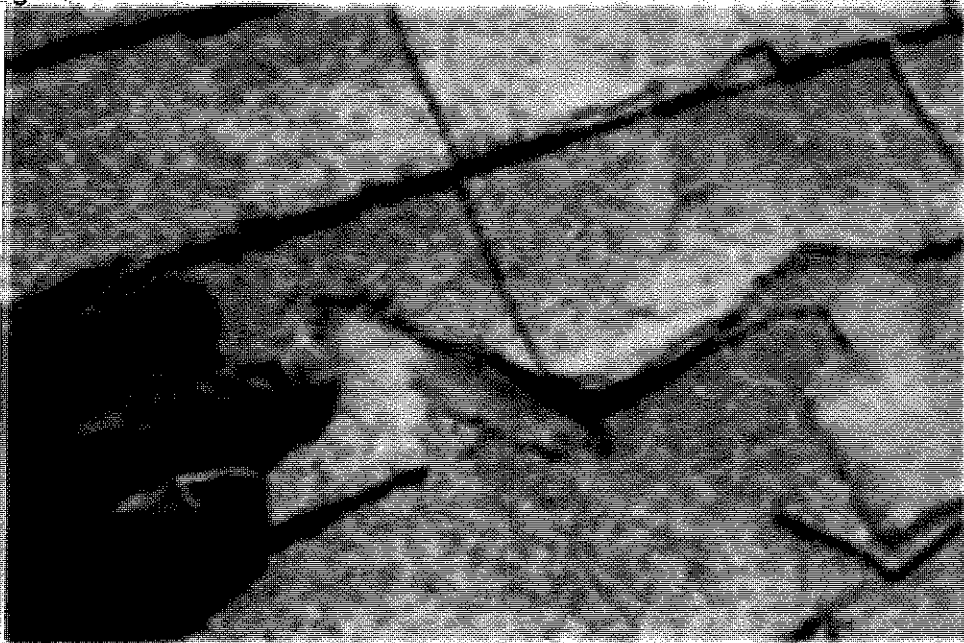
47. Flooring cement on the floor.
